SIGIR INSPECTIONS

SIGIR Project Assessments

Hilla Police Academy in Southern Iraq

PROJECT ASSESSMENT NUMBER: SIGIR-PA-05-032

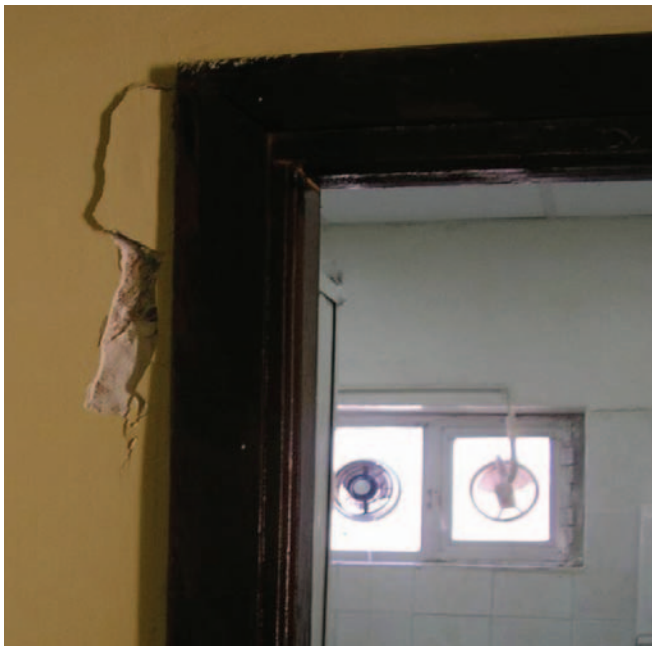
Crack in hallway wall in Instructor
Billeting Area (Photo courtesy of
contracting officer representative)

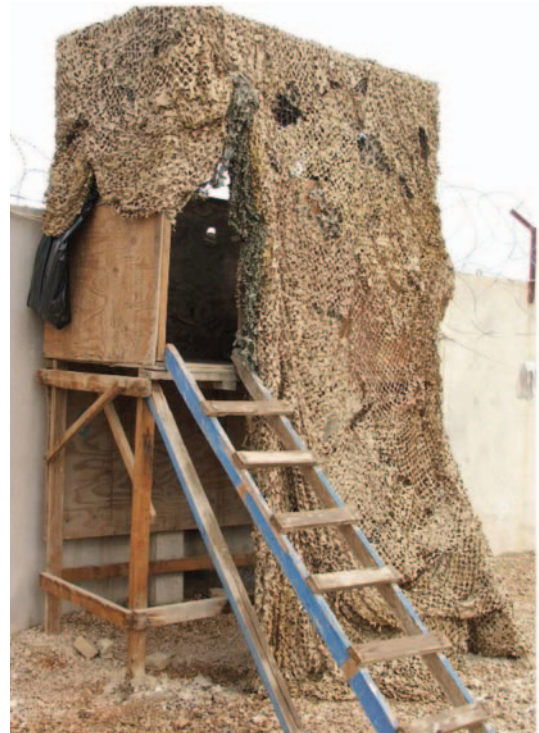
This DFI contract was for security upgrades, including an external lighting system, steel guard towers, and hydraulic steel lifts at each gate, which were not delivered or installed. Instead, makeshift towers were constructed in-house.

Makeshift Guard Tower at the
Hilla Police Academy

If these problems are not addressed, continued degradation of the Police Academy infrastructure will occur. SIGIR recommended that U.S. management agencies conduct a comprehensive facility inspection and repair construction deficiencies at the Police Academy.

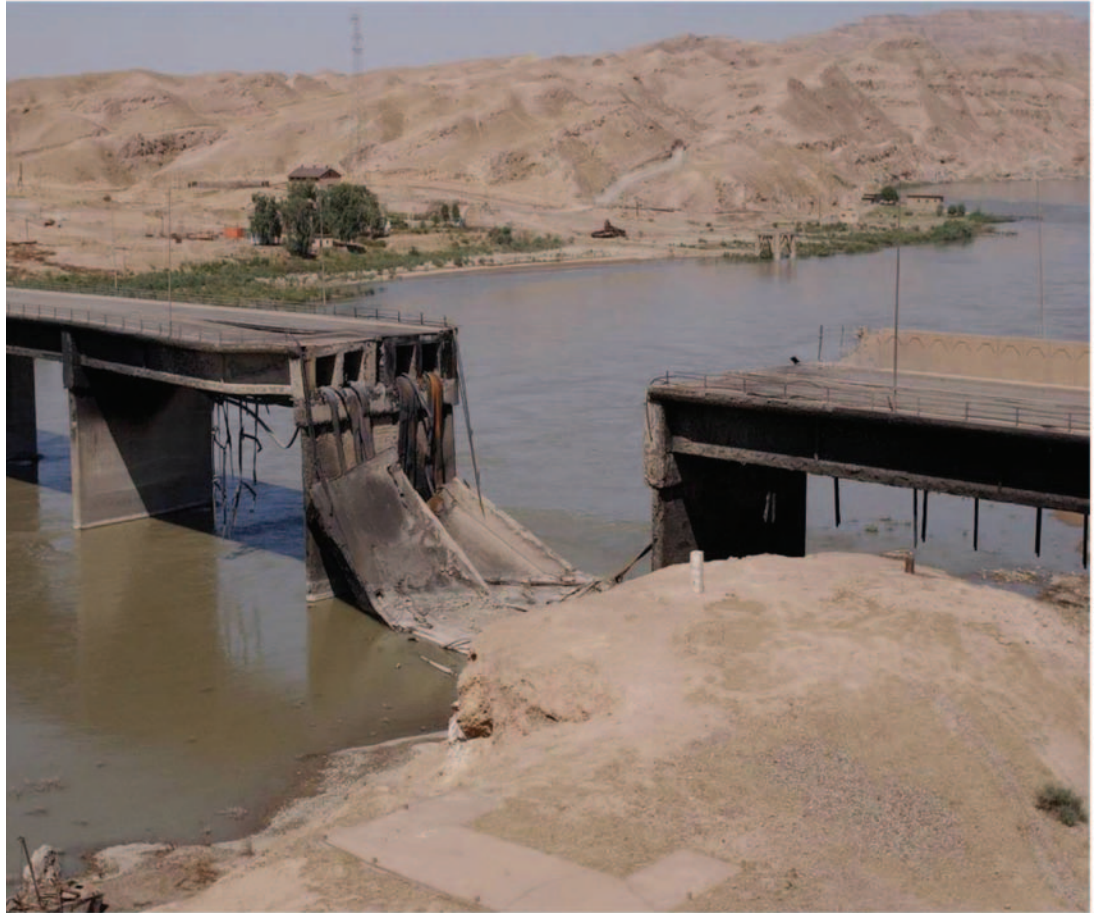
Bomb-damaged bridge crossing the Tigris River at Al Fatah, Iraq

The river crossing project, located close to the town of Al Fatah, Iraq, replaces 16 pipelines that were contained in a bridge over the Tigris River. The lines were severed when the

bridge was attacked by coalition bombing during Operation Iraqi Freedom.

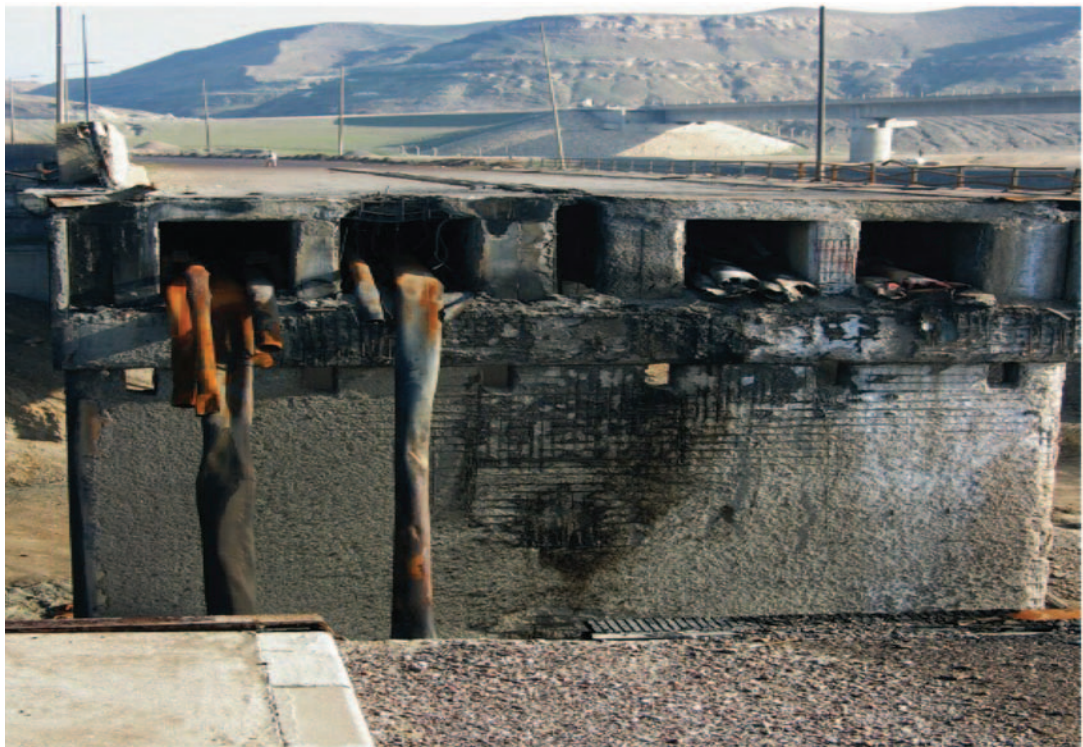
Bridge cross-section showing melted pipes from bomb damage

The project failed because subsurface geologic conditions—such as loose, unconsolidated gravels and cobbles—made it impossible to retain open boreholes for large-diameter pipelines. Although the contractor was warned of these conditions by a consultant, the company awarded the drilling subcontract in September 2003. Neither USACE nor the contractor acted on the consultant's recommendation to perform additional research, which should have prevented the failure. These factors also contributed to the project's failure:

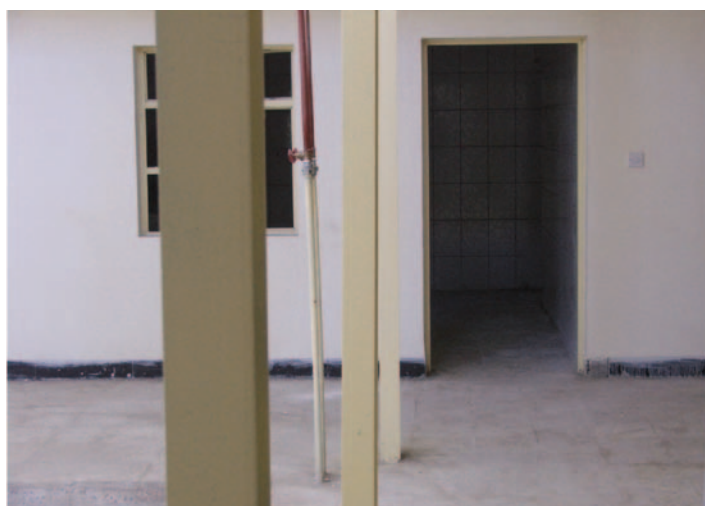
During the design phase, to reduce construction time, the contractor proposed replacing steel-reinforced concrete columns and beams with structural steel I-beams. The contractor prepared 90% design drawings for the structural steel construction. There is no record that the Project and Contracting Office (PCO) reviewed or approved the design changes. During construction, USACE personnel observed that the horizontal I-beams supporting the roof were deflecting under the weight of the roofing material, and some of the I-beams were improperly installed. Further investigation determined that the I-beams

Vertical steel I-beams installed out of proper alignment (not plumb) at border fort

were smaller than design requirements, and normal-strength A36 steel was used instead of high-strength A50 steel. In addition, the design calculations used for the structural steel design did not include snow-load requirements, and the drawings did not specify the required type of steel to be used.

The four border forts are scheduled for structural steel retrofit to reinforce the

installed undersized and standard-strength I-beams and to incorporate the additional snow-load requirements. The retrofit of the structural I-beams had not yet begun at the time of the site visit.

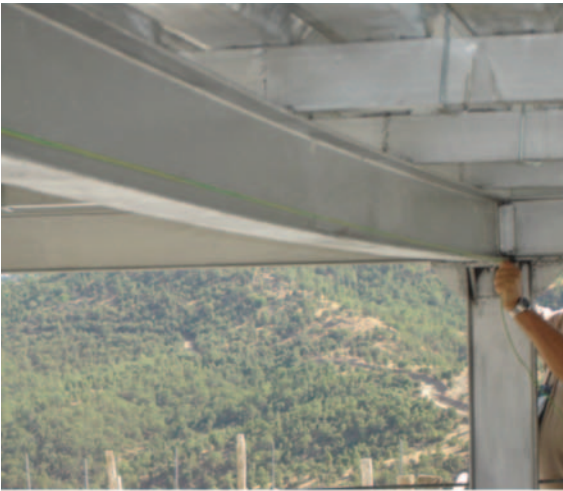
Example of steel I-beam deflection during construction of border forts
(Photo courtesy of the Project and Contracting Office)

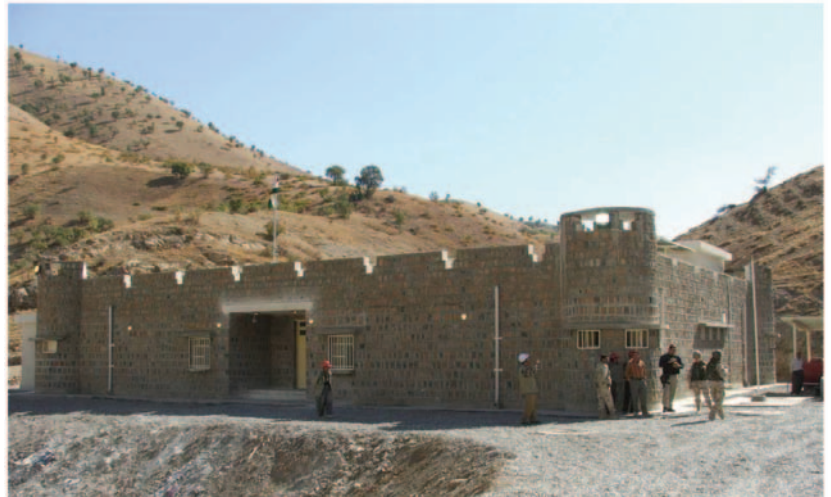
Exterior view of border fort

The SIGIR on-site assessment found that perimeter security walls, berms, concertina wire, and entrance gates had not been constructed as required under the contract. The jail facility, generator units, fuel tanks, and water system were not secured within perimeter security walls or berms. There were no physical restrictions on access to the border-post buildings.

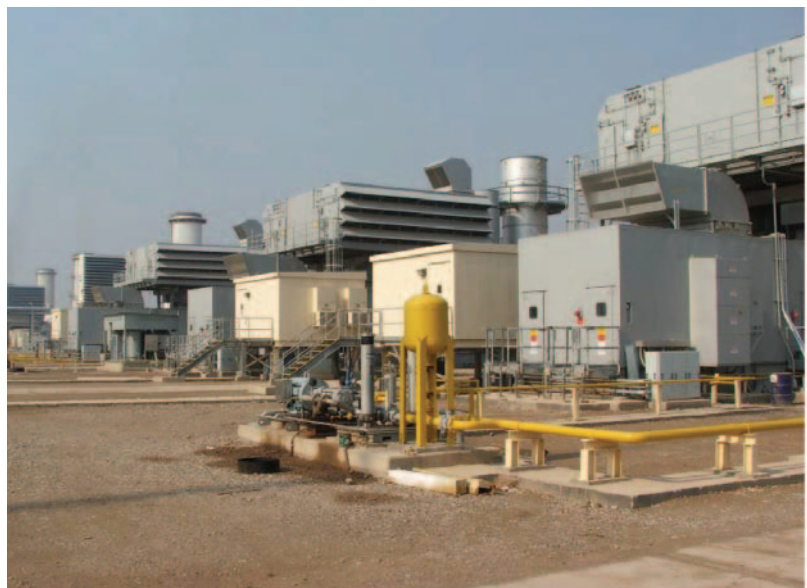
Although GRD-PCO is initiating actions that address sustainability deficiencies identified in the SIGIR on-site assessment, the initiatives have not yet been implemented. Because of the significance of the electrical sector to the well-being of the Iraqi people and economy, SIGIR will continue to inspect electrical projects for sustainability.

Qudas Power Plant gas turbine generator units

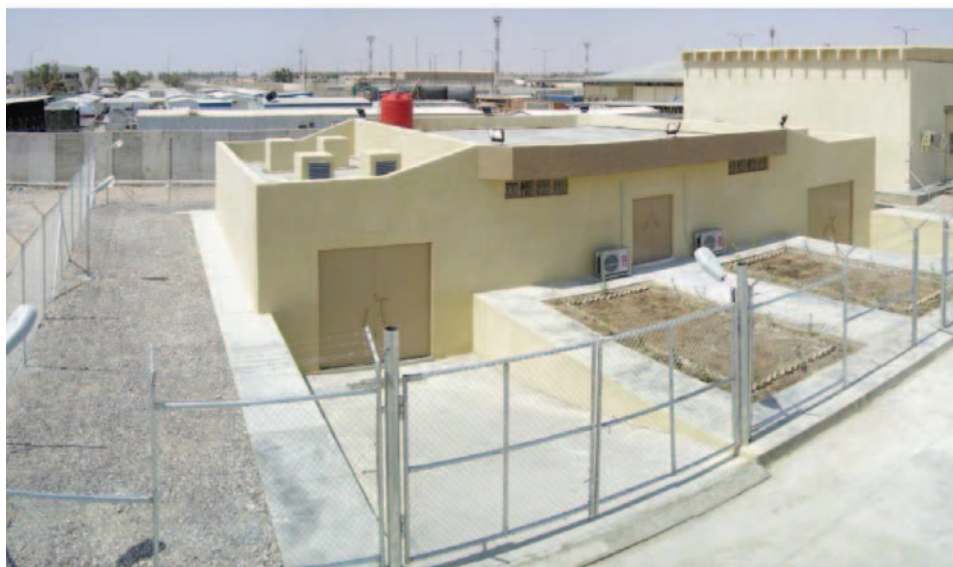
On September 19, 2005, after the final USACE inspection, the ASP building was turned over to the Iraqi Navy. As-built drawings and information on the operation and maintenance of the fire alarm system and the heating, ventilation, and air conditioning (HVAC) were provided to the Iraqi Navy to enhance sustainability. The contract included

Ammunition
supply point
building

warranties on all equipment for 12 months after the issuance of the Taking Over certificate. In addition, the contract certified all operations for 12 months. During SIGIR's visit to the site, a large crack in a stucco wall outside the ASP was identified. The USACE Resident Engineer noted that 6-month and 12-month reviews of completed projects are done to identify any corrective actions required by the contractor. During the warranty period, the customer is required to provide a list of defects in workmanship and equipment to the USACE representative for resolution. The USACE Resident Engineer stated that this crack would be noted and addressed during the 6-month review.

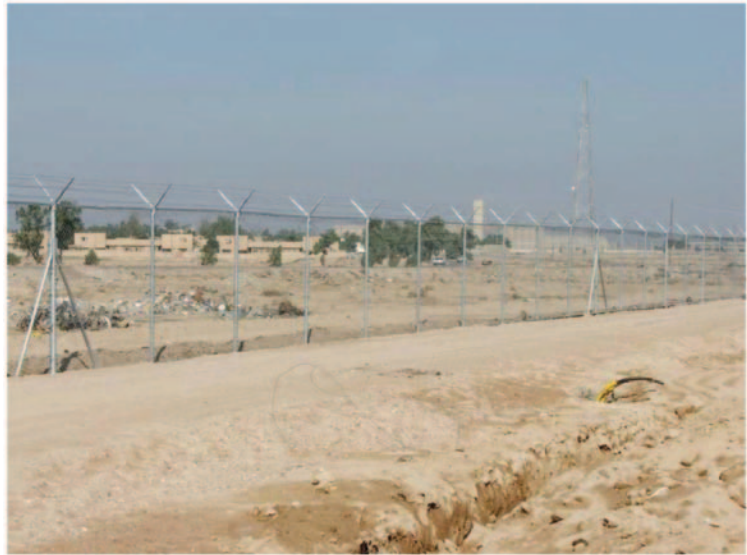
Security fencing and utility trench at Um Qasr

USACE Project Manager and Quality Assurance Representative ultimately accomplished. All work observed by SIGIR appeared to be consistent with the contract specifications.

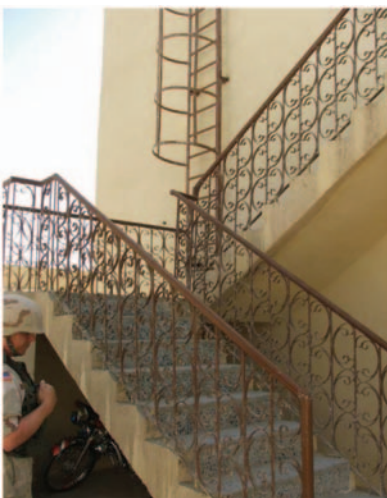
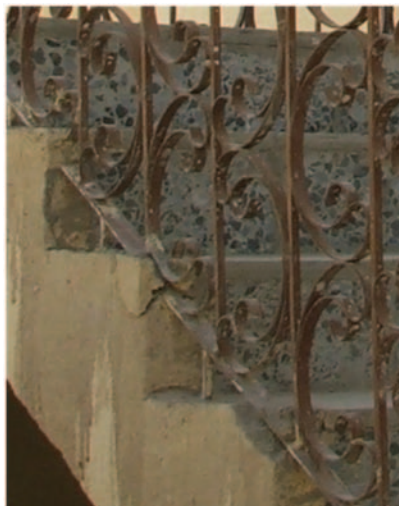
The SIGIR on-site inspection found the demolition of facilities to be complete, with no discrepancies. The inspection also found the dormitory building to be complete and occupied by Iraqi SWAT personnel. The dining facility was also complete, but the assessment team noted discrepancies in the quality and type of appliances in the food preparation area. With respect to exterior construction and renovation work, the on-site assessment disclosed an improperly constructed helicopter pad, improperly anchored light poles, improperly positioned hand railings on exterior building stairs, cracks in the stucco exterior of buildings, and cracks and rough finish in concrete sidewalks.

Improper anchoring of staircase railing

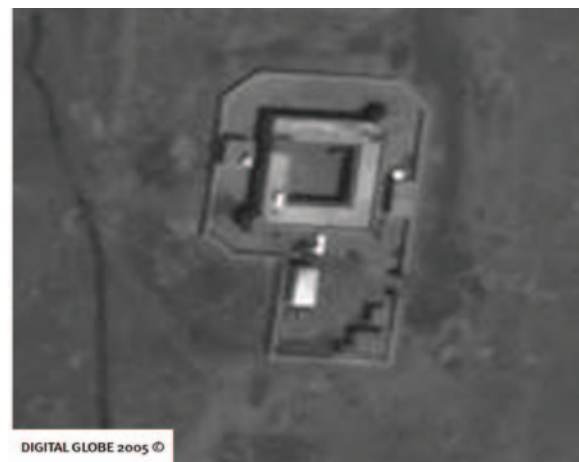
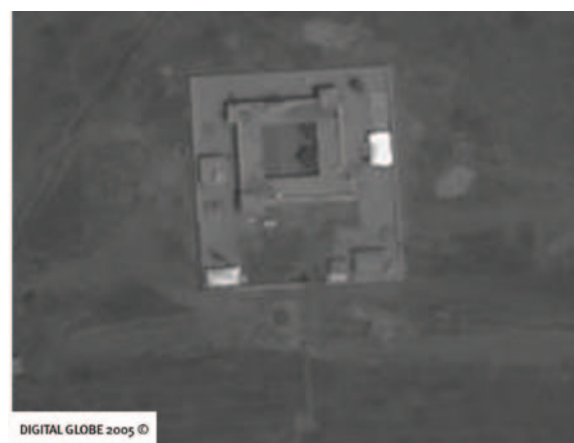
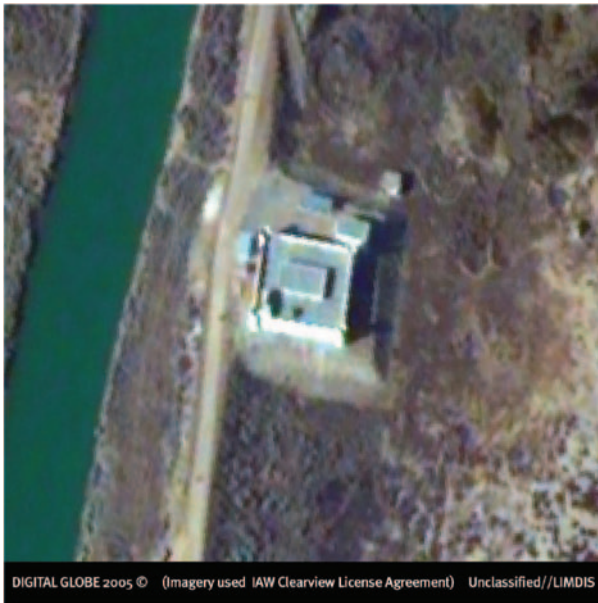
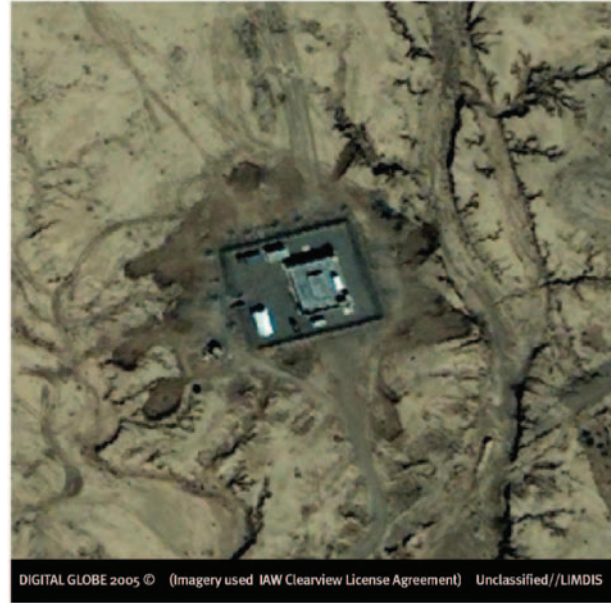
NGA imagery reviewed from May 5, 2005, shows two completed border forts near the northwestern region of the Iraq-Syria border. Visual assessment shows that both forts generally appear to be built according to project specifications.
